Lake Champlain Basin Wetland Restoration Plan

Sample Restoration Concept Plan
Site 4963 Shorham, VT

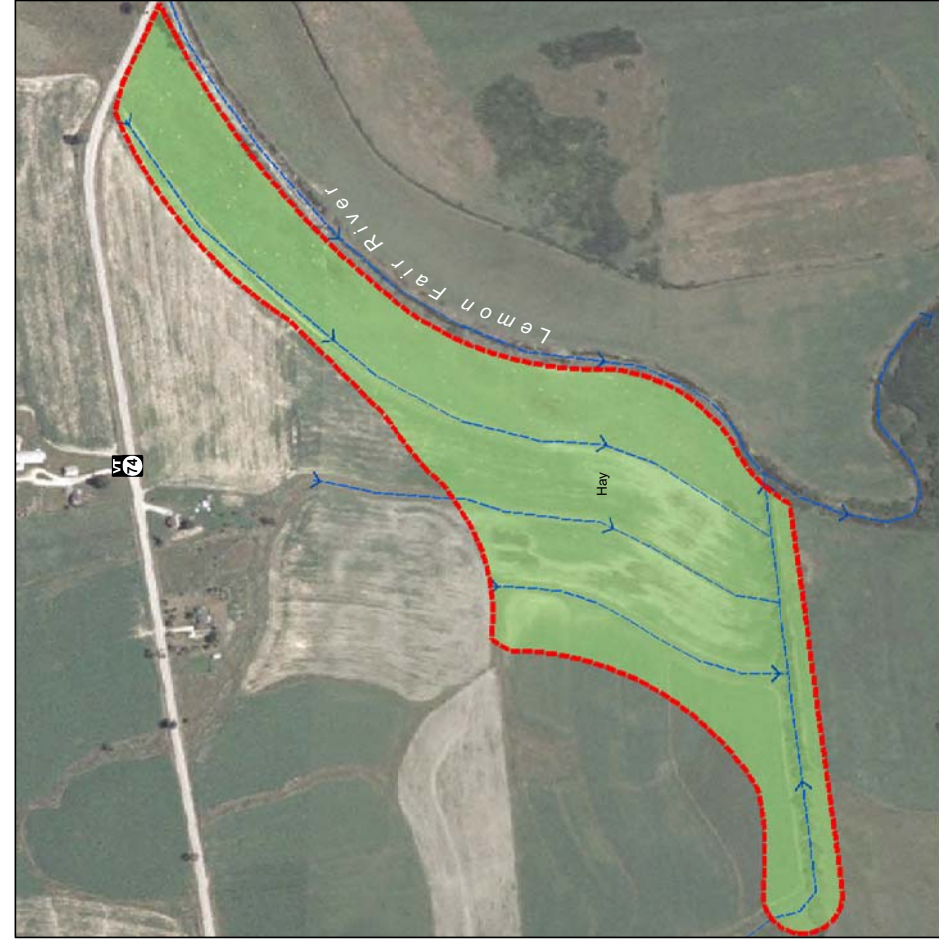
Existing Features

- Restoration Area
- Existing Streams & Ditches
- Hay

Data sources: Base imagery is 2003 NAIP 1M orthophotography. Existing vegetation and hydrography network from 2006 site visits and digitization of existing imagery. Restoration prescriptions by Arrowwood Environmental.

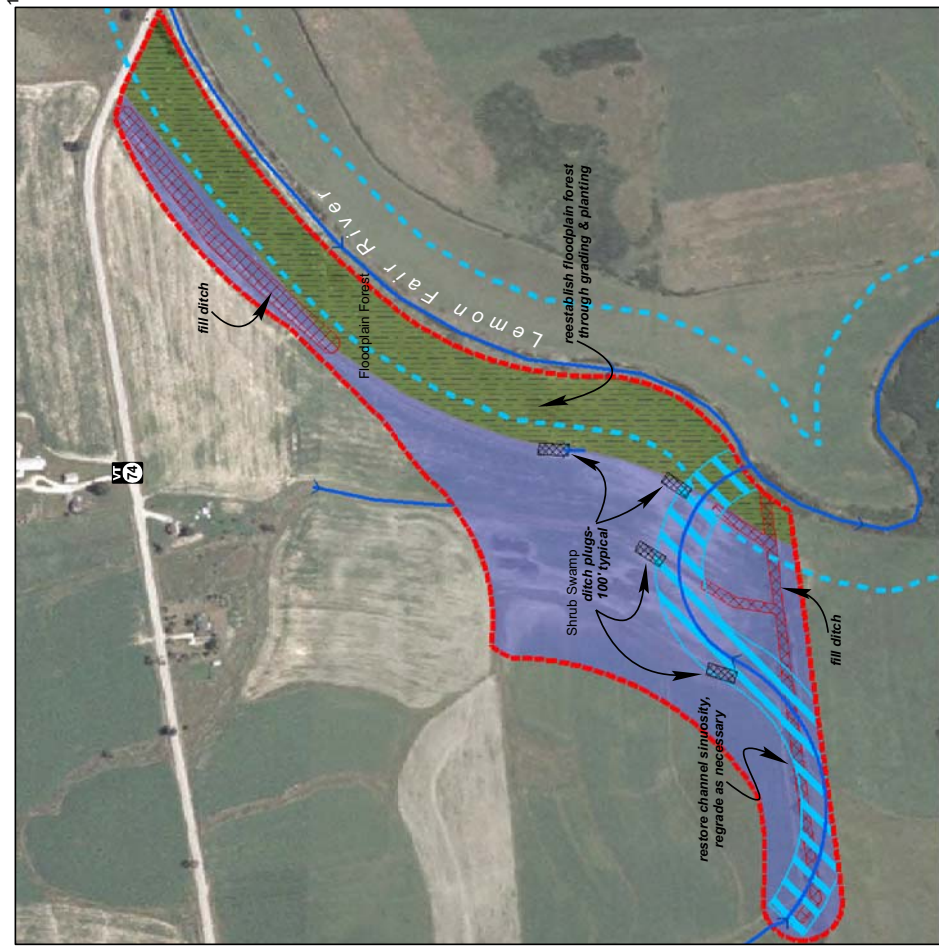
Wetland Restoration

- Restoration Area
- Active Corridor Restoration
- Beltwidth Corridor
- Ditch Fill
- Ditchplug
- Restored Stream Channels
- Shrub Swamp
- Floodplain Forest
