Lake Champlain Basin Wetland Restoration Plan

Sample Restoration Concept Plan
Site 2321 Colchester, VT

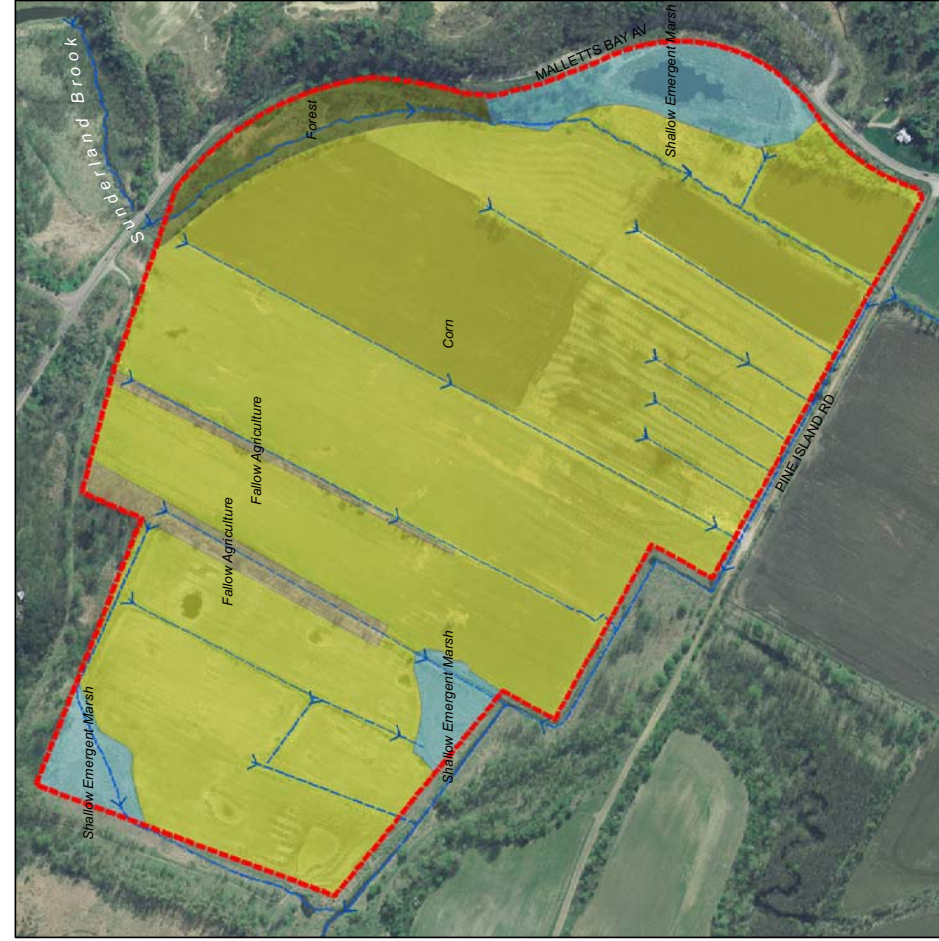
- Existing Features**
- Restoration Area
 - Corn
 - Fallow Agriculture
 - Shallow Emergent Marsh
 - Forest
 - Existing Streams & Ditches

Data sources: Base imagery is 2004 CCSPC 1:1250 orthophotography. Existing vegetation and hydrography network from 2006 site visits and digitization of existing imagery. Restoration prescriptions by Arrowwood Environmental.

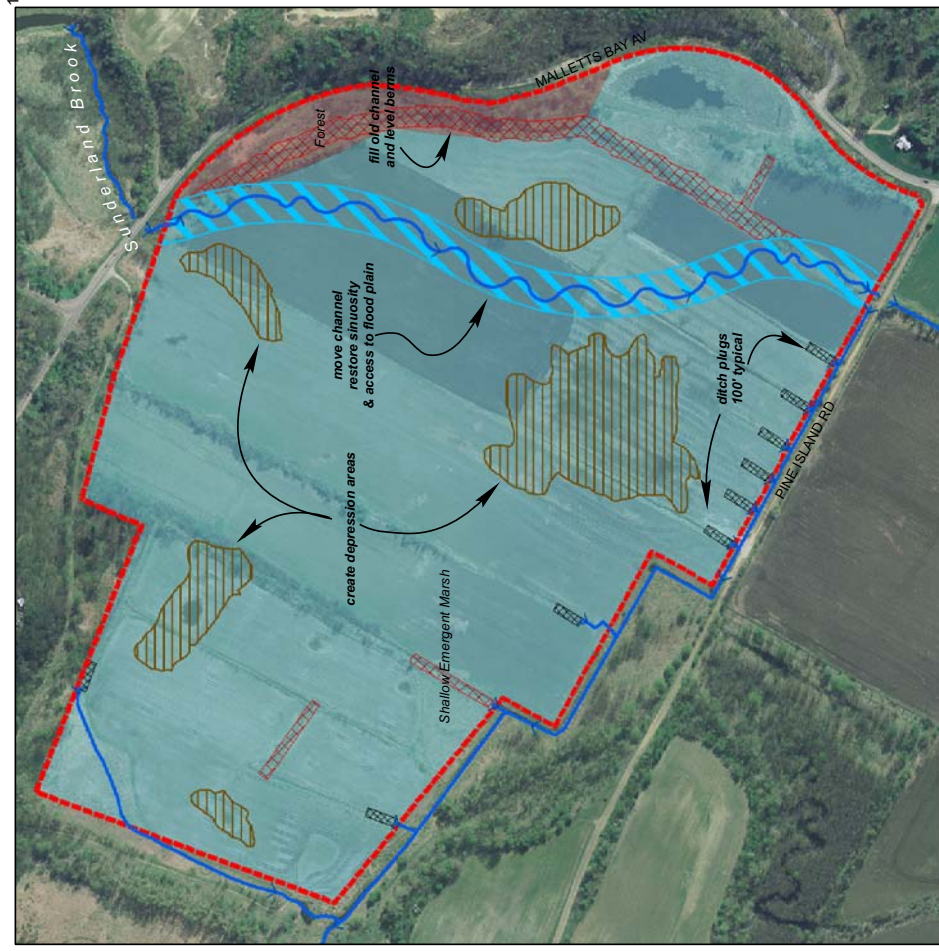
- Wetland Restoration**
- Restored Stream Channels
 - Excavate Depression
 - Shallow Emergent Marsh
 - Forest
 - Restoration Area
 - Ditch Fill
 - Active Corridor Restoration
 - Ditchplug
