# Lake Champlain Basin Wetland Restoration Plan

## Sample Restoration Concept Plan Site 417 Berkshire, VT

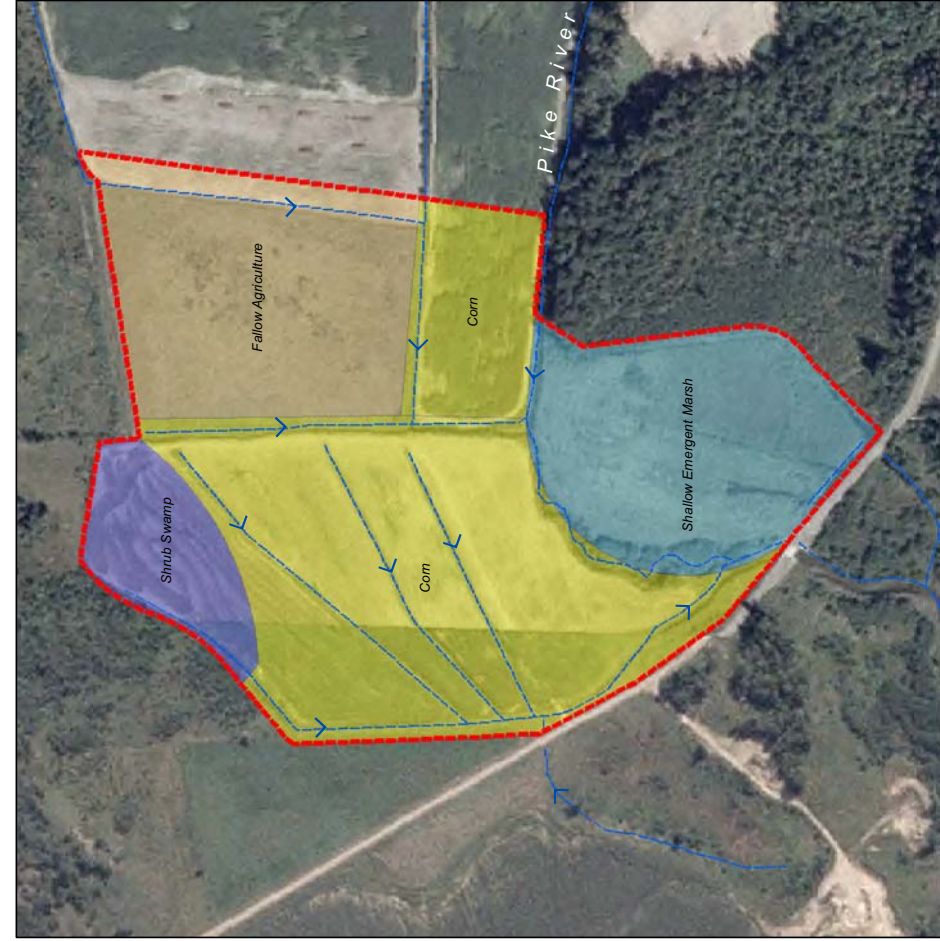
**Existing Features**

- Existing Streams & Ditches
- Fallow Agriculture
- Shallow Emergent Marsh
- Shrub Swamp
- Corn

Data sources: Base imagery is 2003 NAIP 1M orthophotography. Existing vegetation and hydrography network from 2006 site visits and digitization of existing imagery. Restoration prescriptions by Arrowwood Environmental.

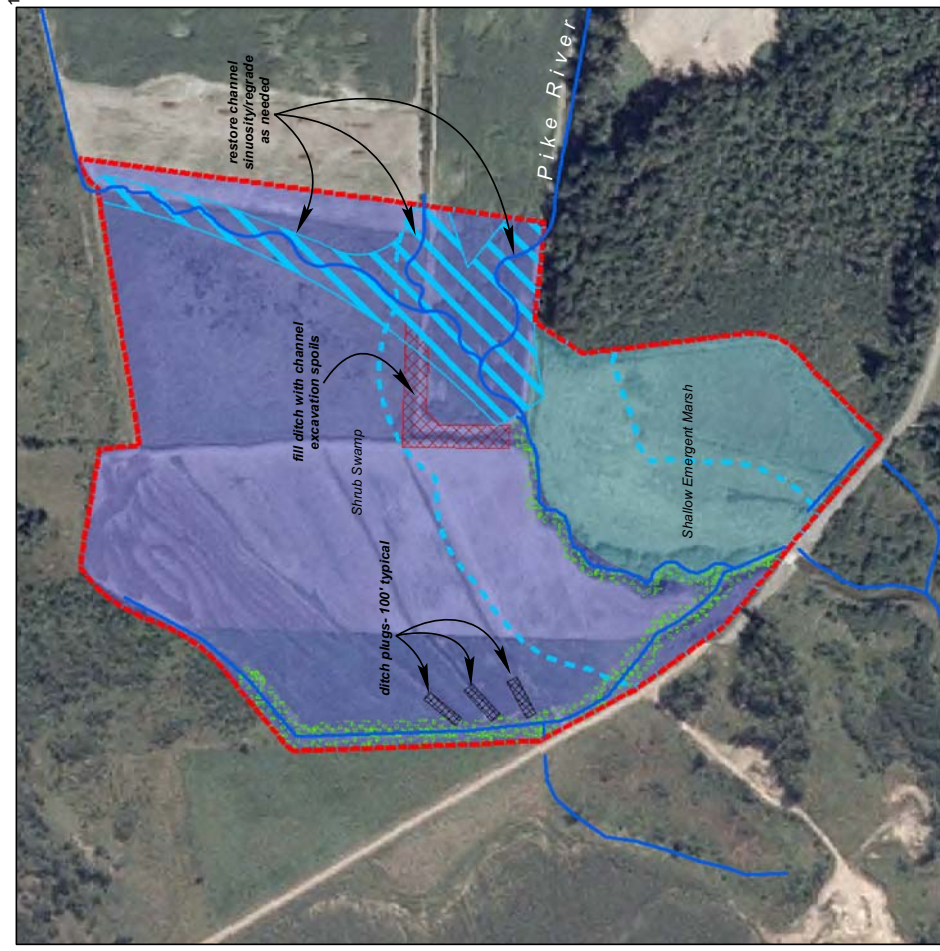
**Wetland Restoration**

- Restored Stream Channels
- Beltwidth Corridor
- Active Corridor Restoration
- Buffer Planting Zone
- Restoration Area
- Ditch Fill & Regrade
- Ditch Plug
- Shrub Swamp
- Shallow Emergent Marsh
